Holiday Inn Reading - West | DisabledGo Holiday Inn Reading - West

Padworth Lane, Bath Road, Reading, Berkshire RG7 5HT

Guide Last Updated: 13/02/2018

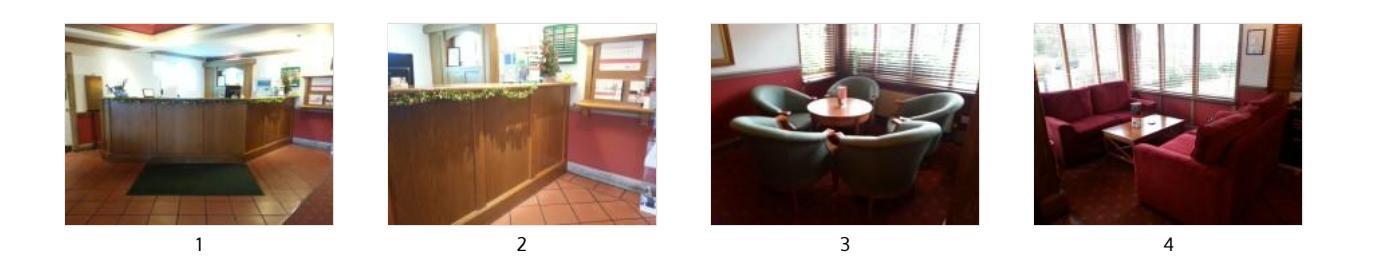
Reception Collapse • The reception point is located ahead as you enter the hotel entrance. • The reception point is approximately 4m (4yd 1ft) from the hotel entrance. • The reception area/desk is clearly visible from the entrance. • The reception area/desk is clearly visible from the entrance. • There is step-free access to the reception point. • There is a clear unobstructed route to the reception point. • There are no windows, TVs, glazed screens or mirrors behind the reception point which could adversely affect the ability of someone to lip read. • The reception counter is not placed in front of a background which is patterned. • The lighting levels at the reception point are good. • The height of the reception counter is high (110cm+). • There is sufficient space to write or sign documents on the counter.

- The counter is staffed.
- Clipboards can be provided to anyone who is unable to use the desk.
- There is a hearing assistance system at the reception point.
- The type of system is a fixed loop.
- The hearing assistance system is signed.
- Staff are trained to use the system.
- Signs and universally accepted symbols or pictograms, indicating lifts, stairs, WCs, circulation routes and other parts of the building are provided in the reception area.
- The type of flooring in the reception area is carpet and tiles.

- There is a waiting area close to the reception point.
- Access to the waiting area is unobstructed.
- There are seats with armrests on both sides.
- There is sufficient space for a wheelchair user to use the waiting area.

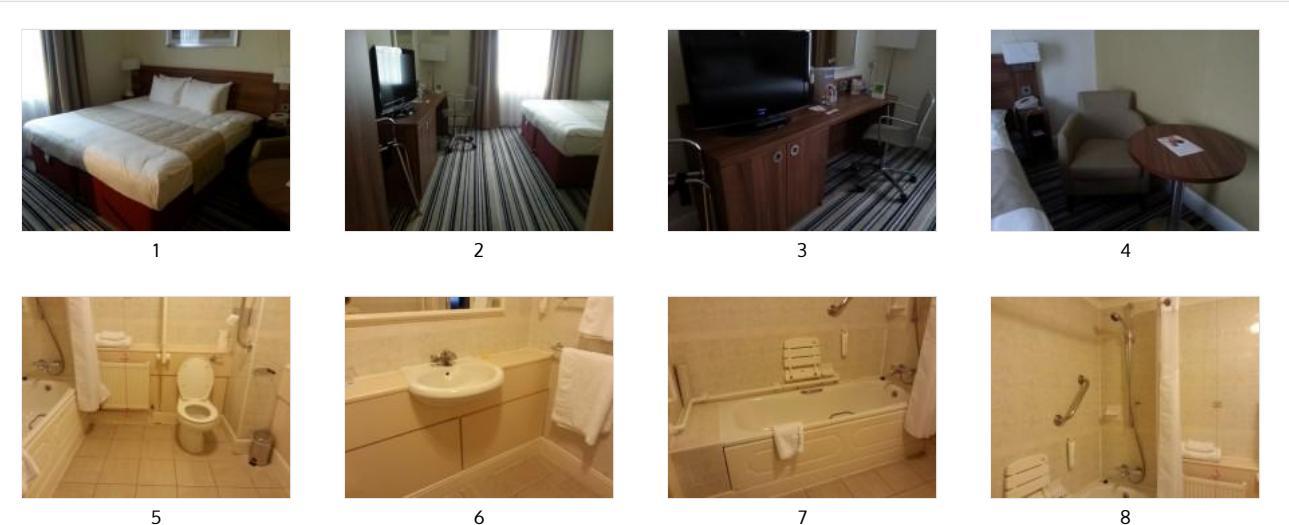
Accessible Room(s) (Rooms 8 and 9)

- The details in this section relates to the accessible room(s) with a bath.
- This type of accessible room is located on the ground floor.
- There is step-free access to this type of accessible room.
- All accessible rooms of this type have similar specifications.
- The ensuite transfer space for the accessible rooms varies from left to right.
- Guests need to open a door between the entrance and the room(s).
- The narrowest width of the corridor leading to the room surveyed was 114cm.

- The emergency pull cord alarm is out of reach (higher than 10cm (4") from floor).
- The emergency alarm rings to reception.
- There is not a flashing fire alarm beacon within the room.
- The type of flooring is carpet.
- The outer windows cannot be opened. There is secondary double glazing which slides with a full length grip.

- The ensuite door opens by sliding.
- The door weight is heavy.
- The door has no lock.
- The width of the door to the ensuite is 82cm (2ft 8in).
- The dimensions of the ensuite are 175cm x 196cm (5ft 9in x 6ft 5in).

- The height of the toilet seat above floor level is 39cm (1ft 3in).
- The toilet has a lid.
- There is a lateral transfer space.
- As you face the toilet pan the transfer space is on the left.

- The ensuite has a lowered bath.
- The height of the side of the bath from floor level is 53cm (1ft 9in).
- The tap type is twist/turn.
- There is a mixer tap.
- There is a shower over the bath.
- The shower head is height adjustable.
- The shower control type is twist/turn.
- There is a/are wall-mounted grab rail(s) available for the bath.

- The colour contrast between the external hotel room door and wall is poor.
- The colour contrast between the internal hotel room door and wall is poor.
- The colour contrast between the hotel room walls and floor is good.
- The colour contrast between the external ensuite door and wall is poor.
- The colour contrast between the internal ensuite door and wall is poor.
- The colour contrast between the ensuite walls and floor is poor.
- The colour contrast between the drop down rail(s) and wall is poor.
- The colour contrast between the wall-mounted grab rail(s) and wall is good.
- The toilet seat colour contrast is poor.
- The lighting levels in the room are low.
- The lighting levels in the ensuite are good.

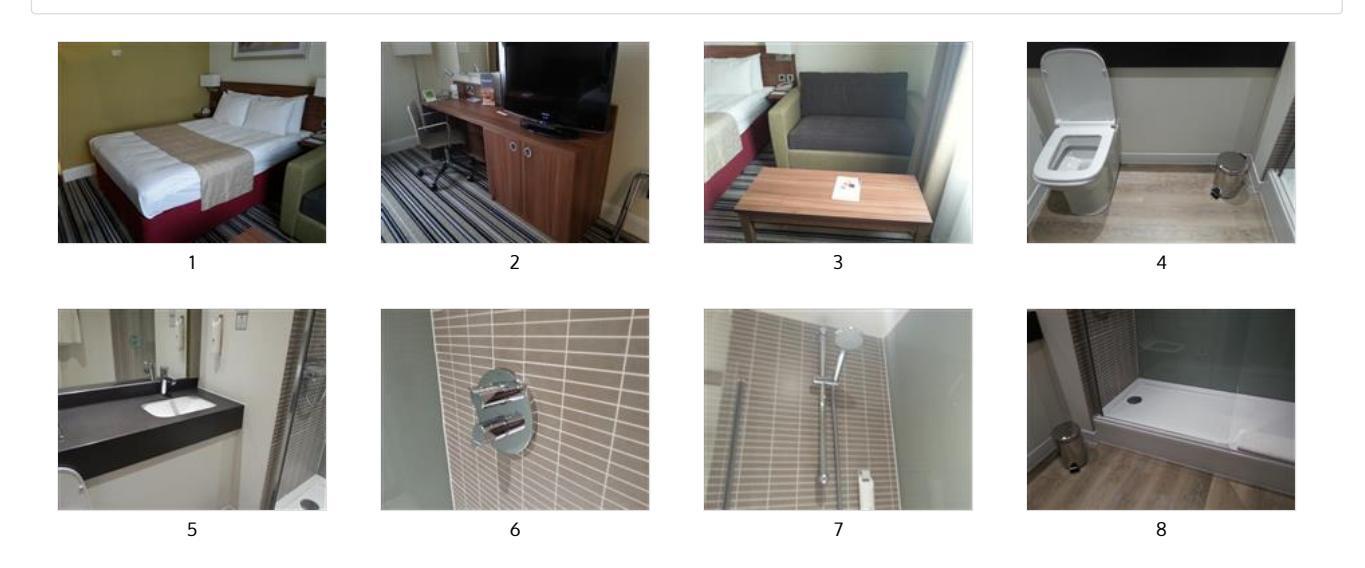
Standard Room(s) (Room 3)

- The room surveyed is located on the ground floor, in the corridor to the left as you enter the hotel entrance.
- The room surveyed at the time of the visit was Room 3.
- There is step-free access to the room surveyed.
- There is numbered signage on or near the room door.
- The width of the door is 70cm (2ft 4in).
- The bed type is double.
- The height of the bed is 60cm (1ft 12in).
- The measurement between the bed base and floor is 5cm (2in).
- Light switches are not within 120cm (3ft 11in) from floor level.
- There is not an emergency alarm in the room.
- There is not a flashing fire alarm beacon within the room.

- The type of facilities within the ensuite include; a toilet, a wash basin and a shower.
- The ensuite door opens inwards.
- The width of the door to the ensuite is 73cm (2ft 5in).
- There is not an emergency alarm within the ensuite.
- There is not a flashing fire alarm beacon within the ensuite.
- The tap type is lever.
- There is a mixer tap.

• There is a deep step to access the shower.

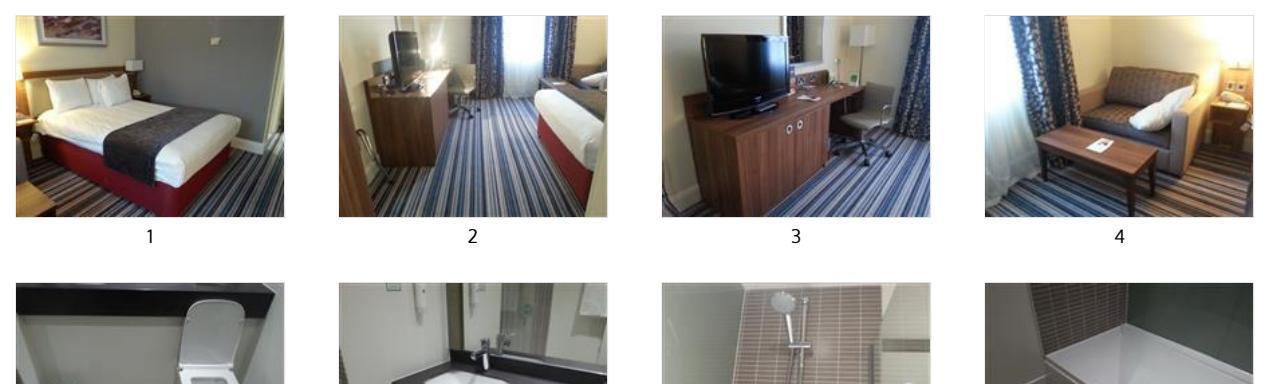
Standard Room(s) (Executive Room 48)

Bedroom Features Collapse -• The room surveyed is located on the first floor, at the rear of the building. • The room surveyed at the time of the visit was Room 48. • There is stepped access to the room surveyed. • There is written and numbered signage on or near the room door. • The width of the door is 69cm (2ft 3in). • The bed type is double. • The height of the bed is 60cm (1ft 12in). • The measurement between the bed base and floor is 5cm (2in). • Light switches are not within 120cm (3ft 11in) from floor level. • There is not an emergency alarm in the room. • There is not a flashing fire alarm beacon within the room. • The type of facilities within the ensuite include; a toilet, a wash basin and a shower. • The ensuite door opens inwards. • The width of the door to the ensuite is 74cm (2ft 5in). • There is not an emergency alarm within the ensuite. • There is not a flashing fire alarm beacon within the ensuite. • The tap type is lever. • There is a mixer tap. Colour Contrast and Lighting Collapse -• The colour contrast between the external hotel room door and wall is poor. • The colour contrast between the internal hotel room door and wall is poor. • The colour contrast between the hotel room walls and floor is good.

• There is a deep step to access the shower.

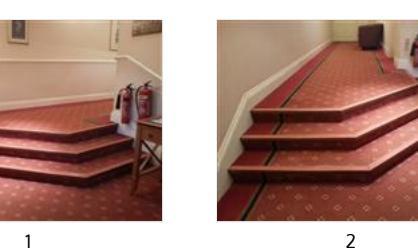
Step(s) (Kennet Boardroom)

- There is a/are step(s) located on the first floor, next to the Readbury Room.
- The step(s) is/are used to access the Kennet Boardroom.
- There is/are 3 step(s).
- The step(s) is/are clearly marked.
- The height of the step(s) is/are not between 15cm and 18cm.
- The height of the step(s) is/are 14cm.
- The going of the step(s) is/are between 30cm and 45cm.
- There is not a/are not handrail(s) at the step(s).
- The lighting levels at the step(s) are good.

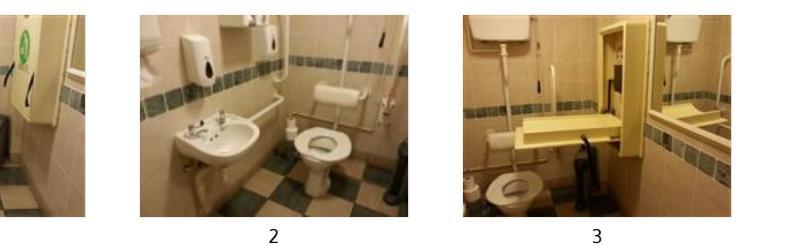
Accessible Toilet(s)

- This is a shared toilet.
- A key is not required for the accessible toilet.
- There is pictorial signage on or near the toilet door.
- The door opens outwards.
- The door is light.
- The door is locked by a lever twist.
- The width of the accessible toilet door is 84cm (2ft 9in).
- The dimensions of the accessible toilet are 144cm x 195cm (4ft 9in x 6ft 5in).
- The accessible toilet does not have an unobstructed minimum turning space of 150cm x 150cm.
- The toilet has not got a non-slip floor.
- There is a lateral transfer space.
- As you face the toilet pan the transfer space is on the right.

• The lateral transfer space is 67cm (2ft 2in). • There is a flush on the transfer side. • There is not a spatula type lever flush. • There is a dropdown rail on the transfer side. • There is an emergency alarm. • The emergency pull cord alarm is not fully functional. • The alarm was out of reach (higher than 10cm (4") from floor) when surveyed. • There is not a flashing fire alarm beacon within the toilet. • Disposal facilities are available in the toilet. • There is a/are female sanitary and open waste paper bin disposal units. • There is a/are coat hook(s). • There are coat hooks in the toilet at 109cm and 156cm from the floor. Position of Fixtures Collapse -• There is a/are wall-mounted grab rail(s) available. • As you face the toilet the wall-mounted grab rail(s) is/are on the left. • There is not a vertical wall-mounted grab rail on the transfer side. • There is a horizontal wall-mounted grab rail on the opposite side of the seat to the transfer space. • There is a mirror. • The mirror is not placed at a lower level or at an angle for ease of use. • There is not a shelf next to the toilet. • The toilet has a backrest. • The height of the toilet seat above floor level is 44cm (1ft 5in). • There is not a toilet roll holder. • There is a wash basin. The wash basin can be reached from seated on the toilet. • The wash basin is not placed higher than 74cm (2ft 5in). • There are no vertical wall-mounted grab rails at the wash basin. • The wash basin tap type is lever. • There is not a mixer tap. • There is a soap dispenser. • The soap dispenser cannot be reached from seated on the toilet. • The height of the soap dispenser is 98cm. • There is a towel dispenser. • The towel dispenser cannot be reached from seated on the toilet. • The towel dispenser is placed higher than 100cm (3ft 3in). • The height of the towel dispenser is 117cm (3ft 10in). • There is a hand dryer. • The hand dryer cannot be reached from seated on the toilet. • The hand dryer is placed higher than 100cm (3ft 3in). • The height of the hand dryer is 130cm (4ft 3in). Colour Contrast and Lighting Collapse -• The contrast between the external door and wall is fair. • The contrast between the internal door and wall is poor. • The contrast between the dropdown rail(s) and wall is poor. • The contrast between the wall-mounted grab rail(s) and wall is poor. • The toilet seat colour contrast is poor. • The contrast between the walls and floor is fair. • The lighting levels are good.

- Baby changing facilities are located within the accessible toilet.
- The baby change table is not set against the wall, permanently fixed at 75cm from the floor.
- The baby change table is not height adjustable.
- The height of the baby change table once extended is 98cm (3ft 3in).

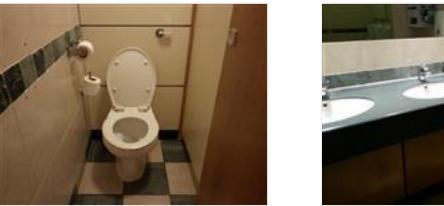
Standard Toilet(s)

- The female and male toilet facilities that were surveyed are located on the ground floor, in the reception foyer.
- The female and male toilets are approximately 10m (10yd 2ft) from the hotel entrance.
- There is step-free access to the female and male toilet(s).
- There is pictorial signage on or near the toilet door.
- An ambulant toilet with wall-mounted grab rails is not available.
- The wash basin tap type is lever.
- There is not a flashing fire alarm beacon within the toilets.
- Lighting levels are good.
